**Docket No. 217 – Development and Management Plan Inspection**

**Norwalk Substation**

**Date:** August 17, 2006

### Plumtree Substation

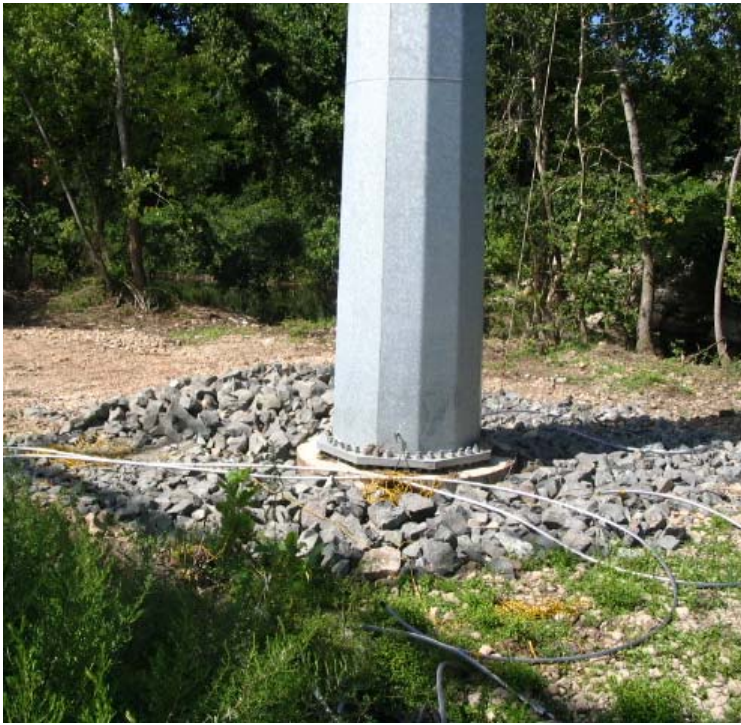
(Norwalk Substation): Photo on the left shows the stone remaining in place at the base of the 345kV turning structure. Overhead crews were pulling wire at the substation. (Plumtree Substation): Photo on the right shows a current overview of the yard. 8/16/06

- MJ Electric remain on site to pull wire between the station and the ROW. 8/3-8/17/06	- None at this time. 8/17/06	-N/A
	-Stone remains in place around the base of the 345kV turning structure. 8/17/06	-Continue to monitor. Consider re-vegetating the adjacent bank if feasible 8/17/06	- N/A
Erosion and Sediment Controls	- Erosion on the slope of the river appears to be forming again near the structure. 6/28-8/17/06	- Continue to monitor and attempt to make the area more natural/ vegetated if feasible. 5/25-8/17/06.	-N/A

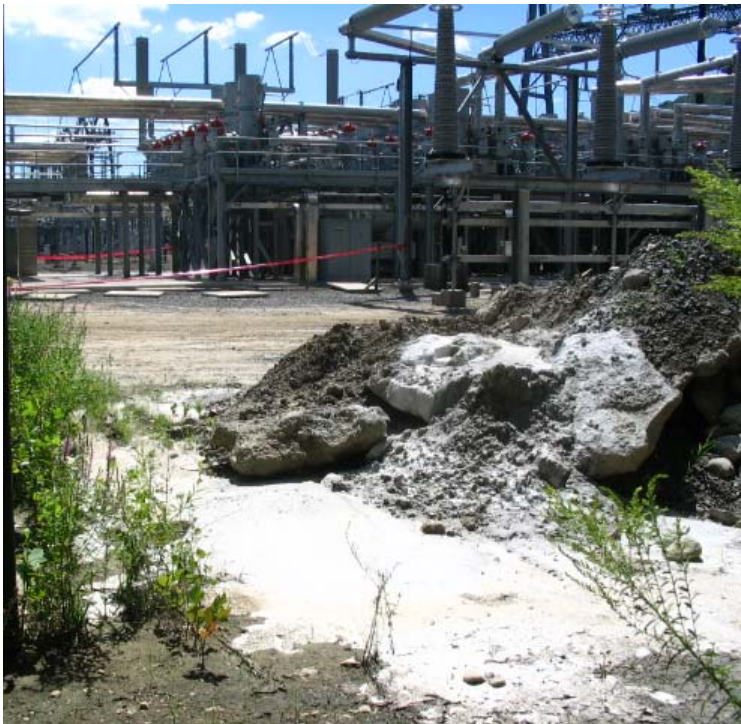
(Plumtree Substation): Photo on the left shows a concrete washout at an existing stockpile. The material did not leave the yard but it should be contained better in a designated area. Photo on the right shows a view of the work continuing on the recent structures and forms. 8/16/06

Areas of Inspection	Observation	Recommended Action	Corrected Action
Dewatering	not observed at the inspection and the site is drying out. 8/16/06. -See spill section regarding concrete washouts.	methods of controlling dewatering without letting unfiltered water off-site. 8/9/06	
Blasting	- No blasting is occurring on site at this time.	- None at this time.	-N/A
Spills and Material Storage	- No spills or leaks were noted. Now that machinery has returned, continue to monitor. 8/16/06  -However, a concrete washout was noted at an existing stockpile. It remained within the yard but drivers should be directed to a designated, contained area for washouts. 8/16/06	- The contractors should remain vigilant about securing and handling fuel containers. - Keep all vehicles maintained well (i.e. no apparent fluid leaks) if they will be used or stored on site. Check equipment status on a regular basis. - Report spills to the office immediately, even if they are being controlled.	-N/A  - Inform drivers and create a designated area.
